Township Of East Windsor Green Team

# East Windsor Township Water Story

Completed in partial fulfillment of the requirements for sustainable Jersey's Water Story Action

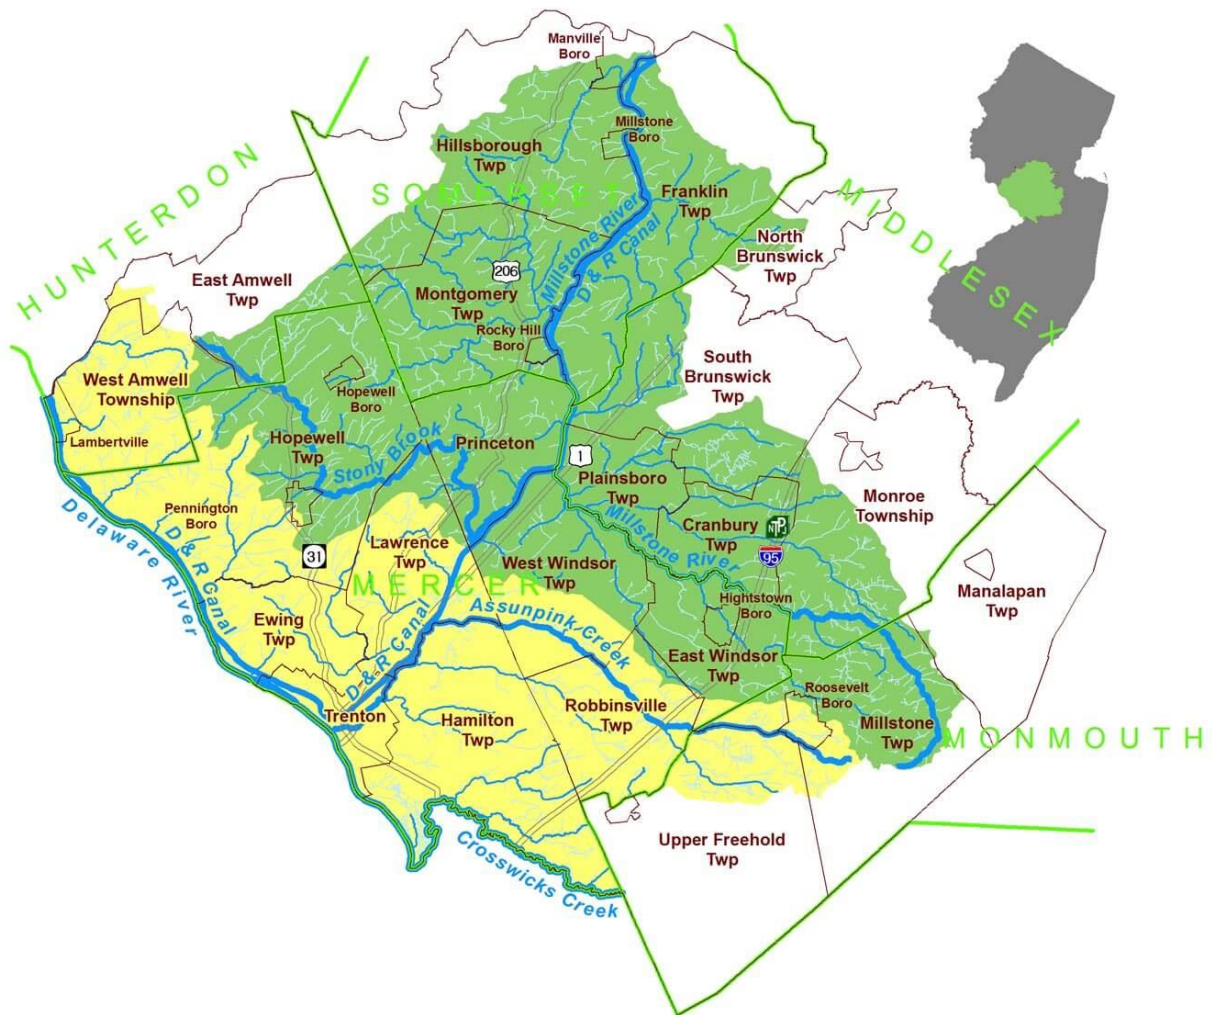
Fig. 5 - Upper Millstone Watershed

As shown in Fig 5, creeks and tributaries in East Windsor Township are classified as FW2-NT (Freshwater which maybe subject to man made wastewater discharges, with no trout). In accordance with N.J.A.C. 7:98 Surface Water Quality Standards, the primary use of these streams in East Windsor Township is for maintenance, migration, and propagation of the natural and established biota.

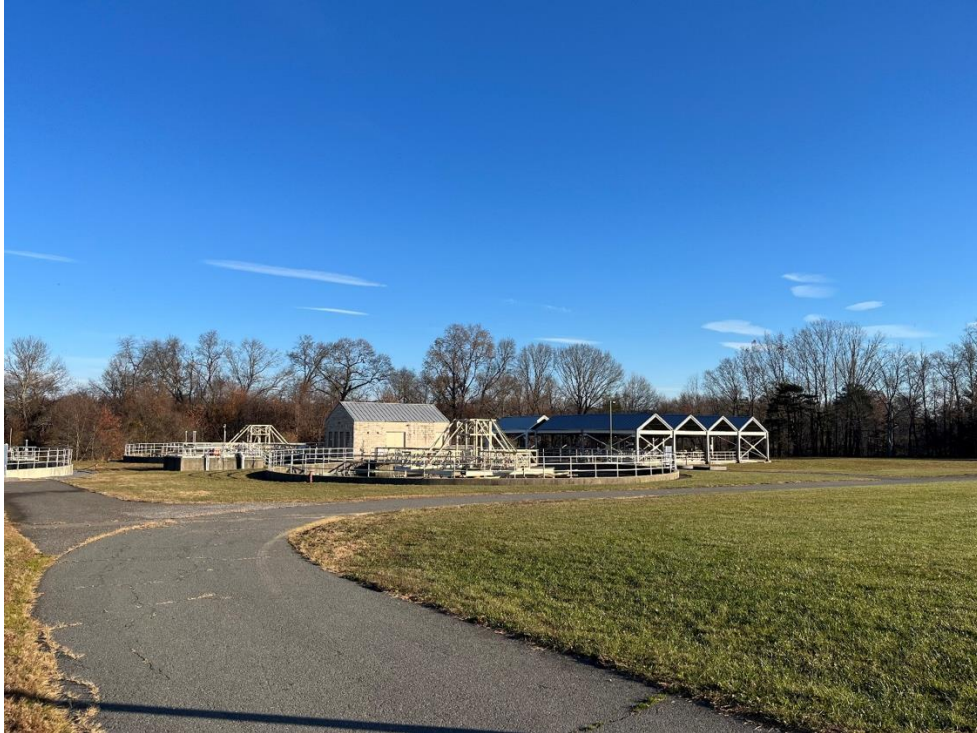
Fig. 18 – 2010 Infrastructure Project

In 2010, East Windsor Municipal Utilities Authority embarked on a major upgrade to its facilities. This was a \$20 million dollar project that was funded by the State Revolving Fund (SRF currently called the N.J. I Bank). Low interest loans and some principal forgiveness through the NJDEP were utilized (Fig. 18 – 21).

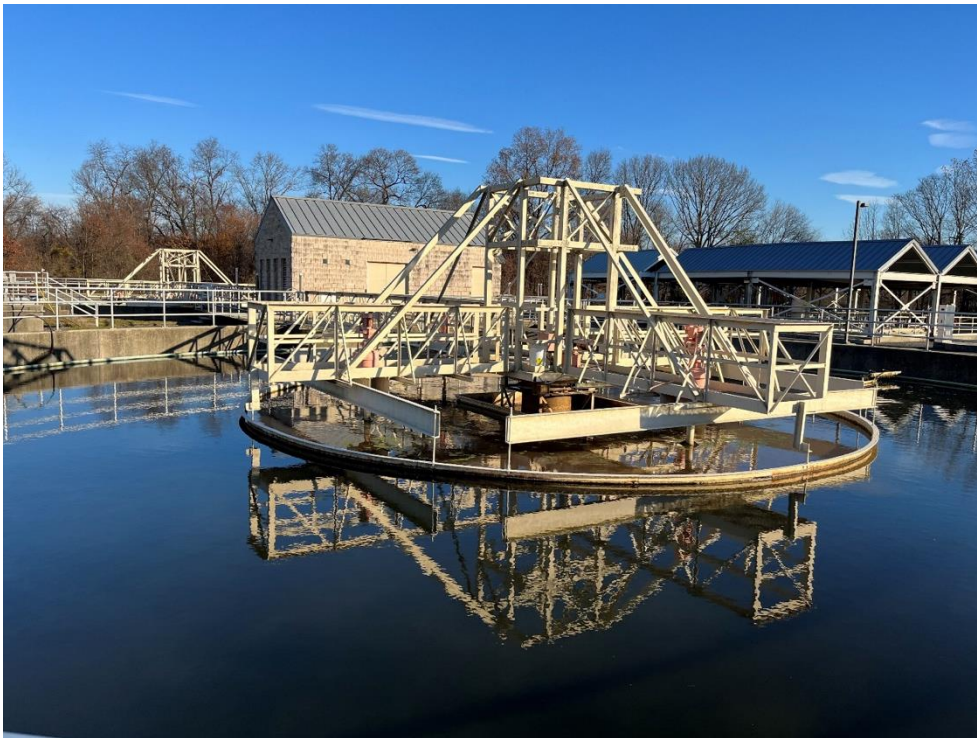
Fig. 19 – 2010 Infrastructure Project - Clarifiers

High efficiency blowers were installed to enhance the biological treatment in the aeration basing. Two additional clarifiers were installed to help remove small particles (suspended solids) more efficiently and Ultra Violet disinfectant equipment (replaced sodium hypochlorite system) installed to remove all bacteria from the effluent. The tertiary sand filters were retrofit and an additional filter bed was installed. This has not only reduced East Windsor MUA’s operating cost; it has also enhanced the Millstone Rivers water quality immensely.

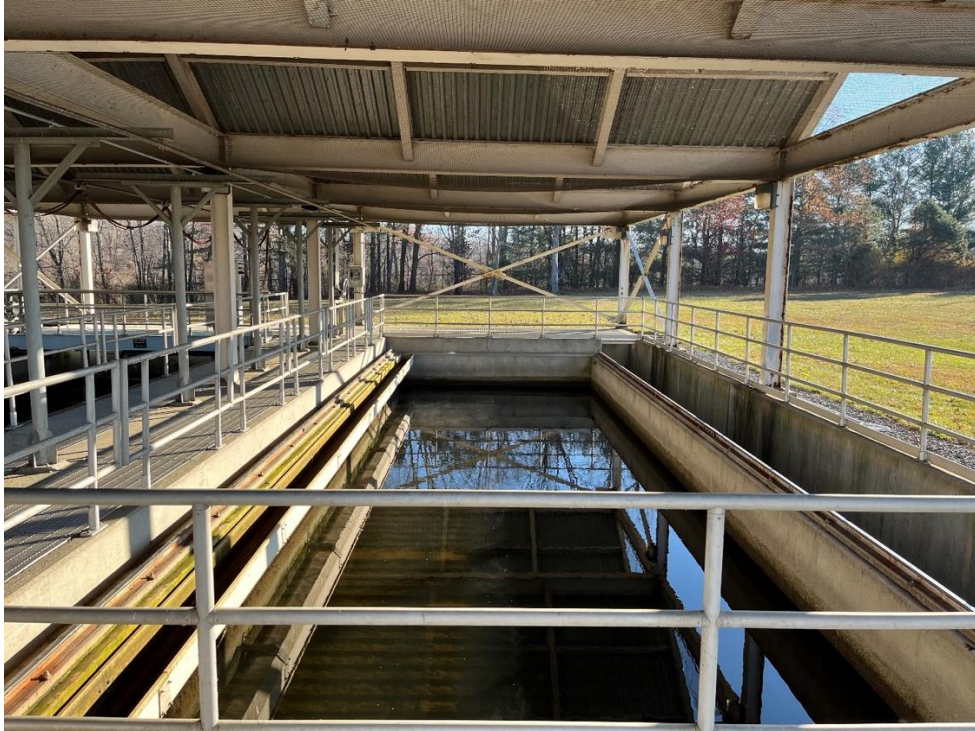
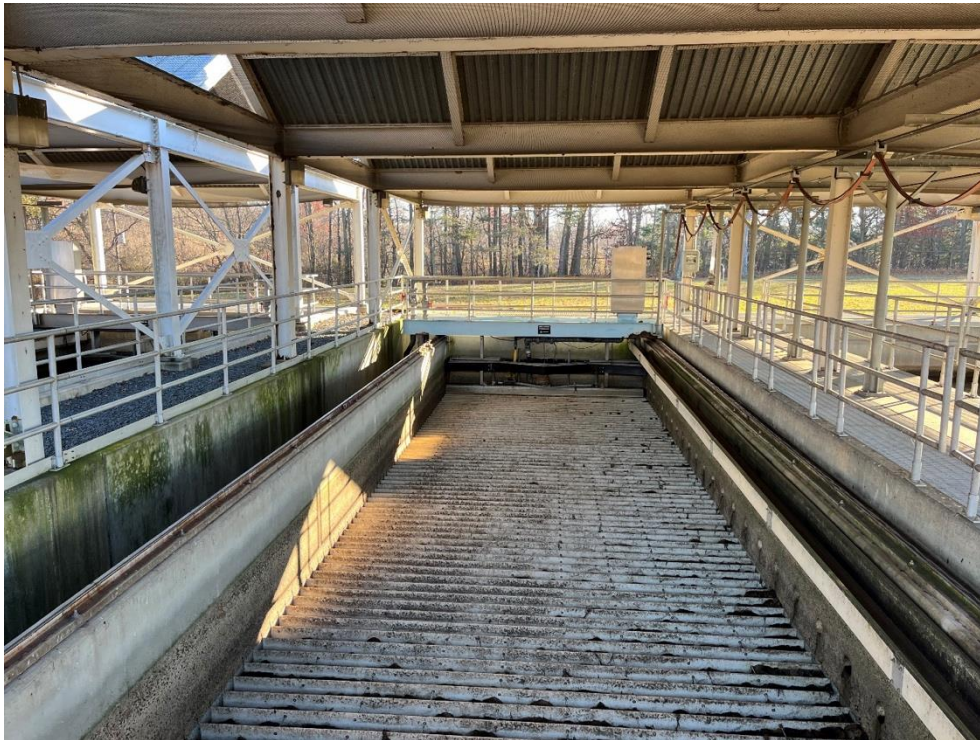
Fig. 20 – 2010 Infrastructure Project – Tertiary Filters

Fig. 20a – 2010 Infrastructure Project – Tertiary Filters

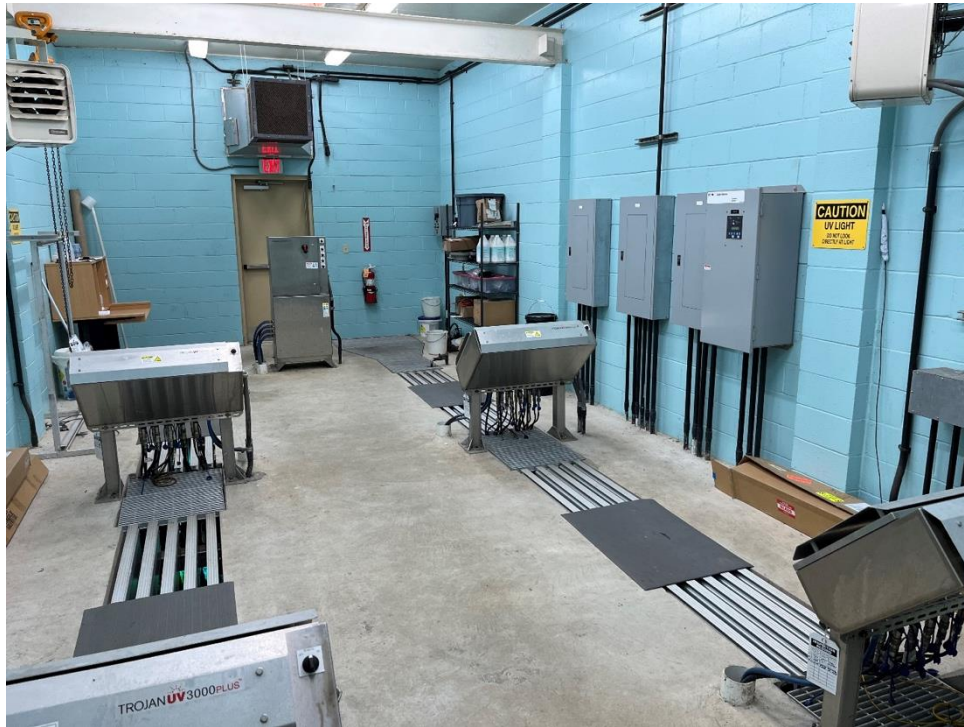
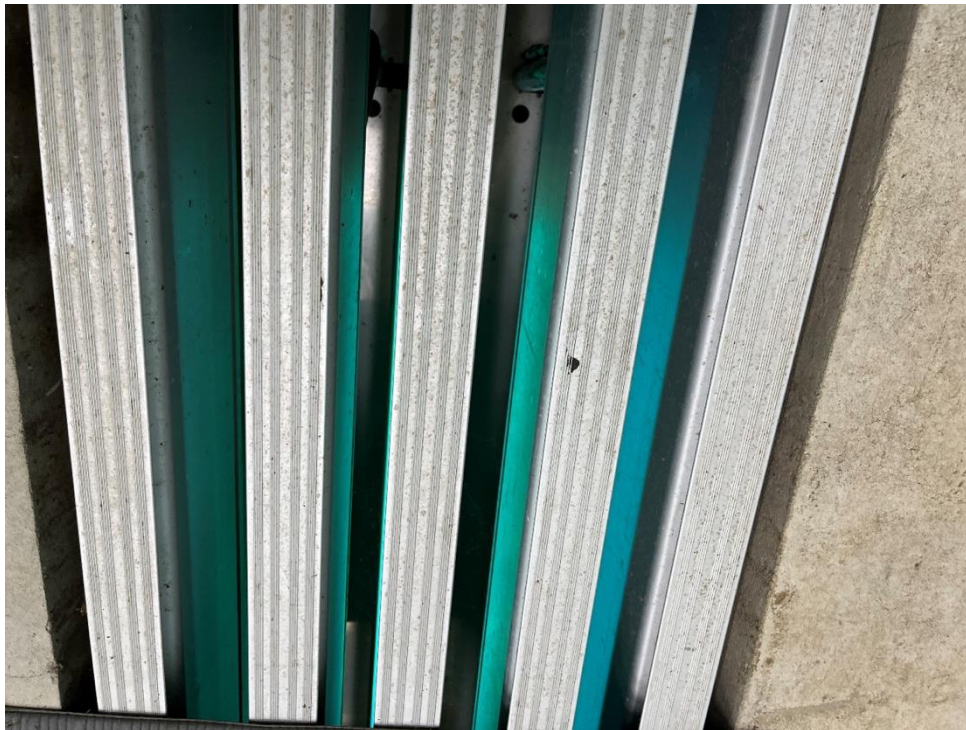
Fig. 21 – 2010 Infrastructure Project – U. V. Désinfectant

Fig. 21a – 2010 Infrastructure Project – U. V. Disinfectant

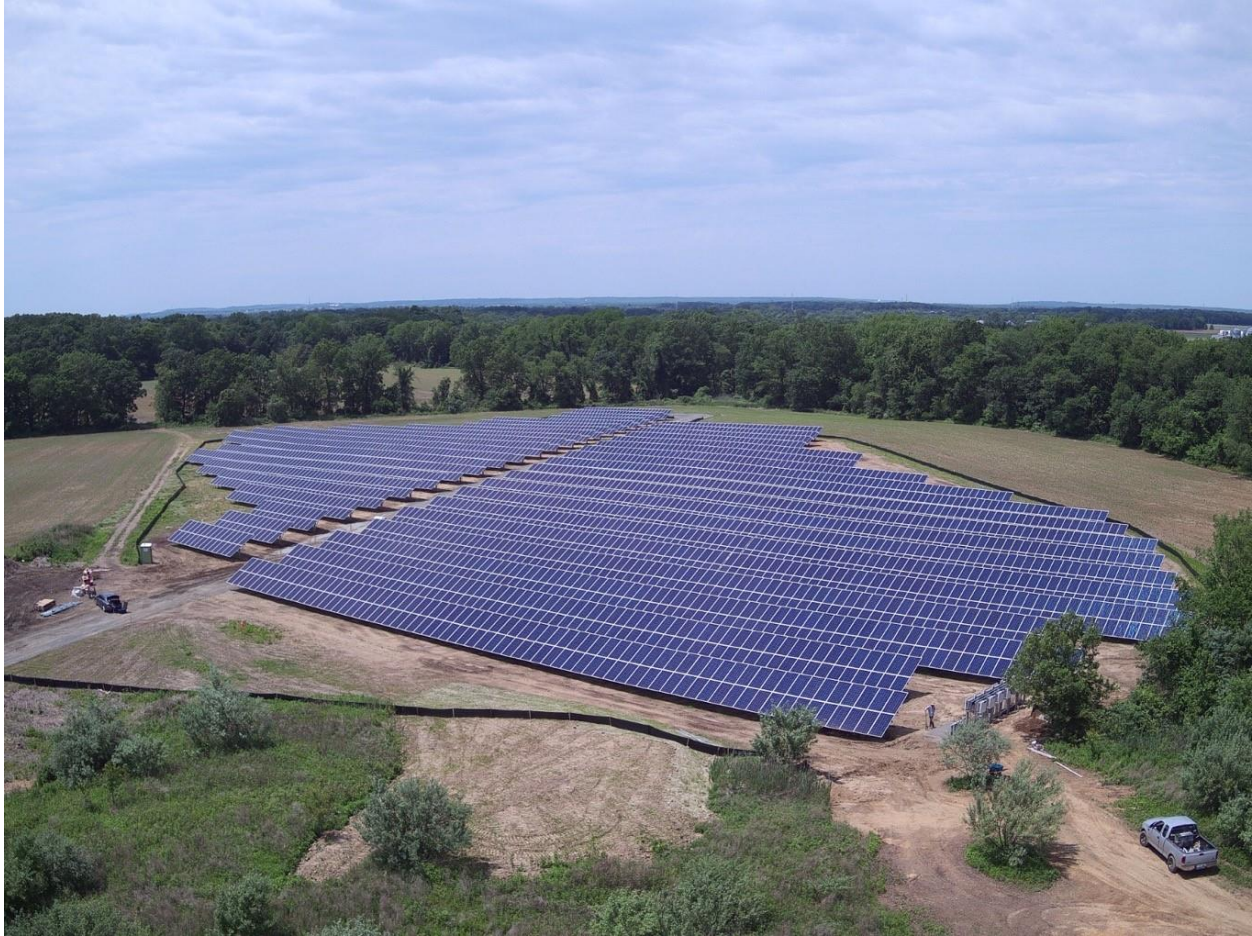
Fig. 22 – 1.7 Mega Watt Solar Field

In 2018, the East Windsor Municipal Utilities Authority, with the assistance from the Township Mayor and Council, embarked on a significant solar project to help reduce the carbon footprint while decreasing electrical costs. A 1.7-megawatt solar field was built at no cost to the ratepayers. This solar field supplies 90% of all power to the wastewater plant. The East Windsor Municipal Utilities Authority is currently replacing (through the agency's asset management plan) low efficiency motors with high efficiency premium motors with variable frequency drives (VFD's) to lower the carbon footprint further and achieve a 100% solar powered wastewater treatment facility.

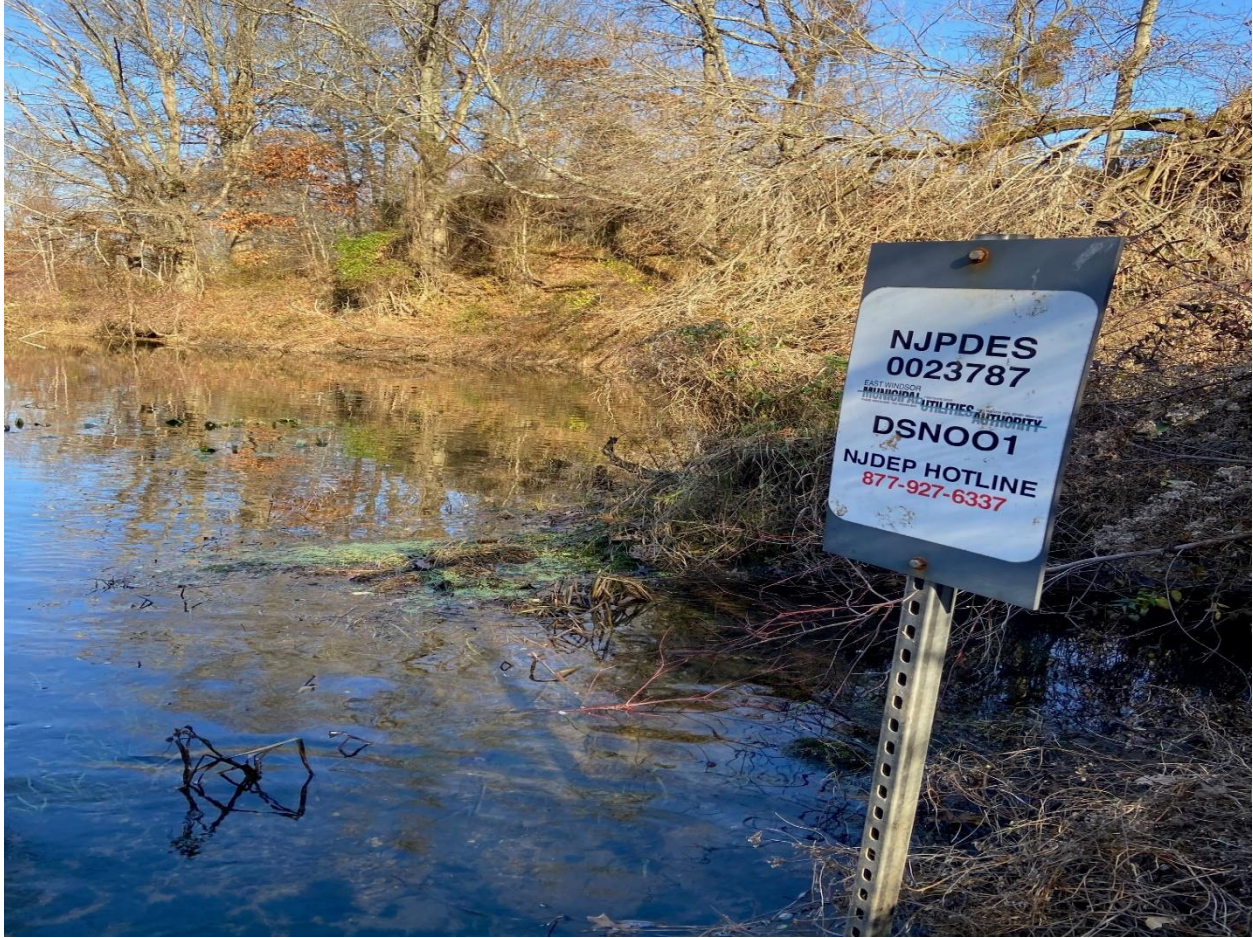
Fig. 23 – East Windsor MUA NJPDES Permit – Outfall Pipe

The East Windsor Municipal Utilities Authority wastewater treatment facility is regulated by the New Jersey Pollutant Discharge Elimination System (NJPDES permit, ID number NJ0023787. East Windsor Municipal Utilities Authority wastewater treatment plant discharges in to the Millstone River. The NJPDES Surface Water Renewal Permit is effective 1/1/2020 through 3/31/2025, as required and reported in the latest NJDEP Standard Compliance Inspection.
