## STORMWATER MANAGEMENT TESTING REPORT

# **Proposed Block 57, Lot 9.01**

**East Windsor Township, Mercer County, New Jersey**

**GEO-TECHNOLOGY ASSOCIATES, INC.**

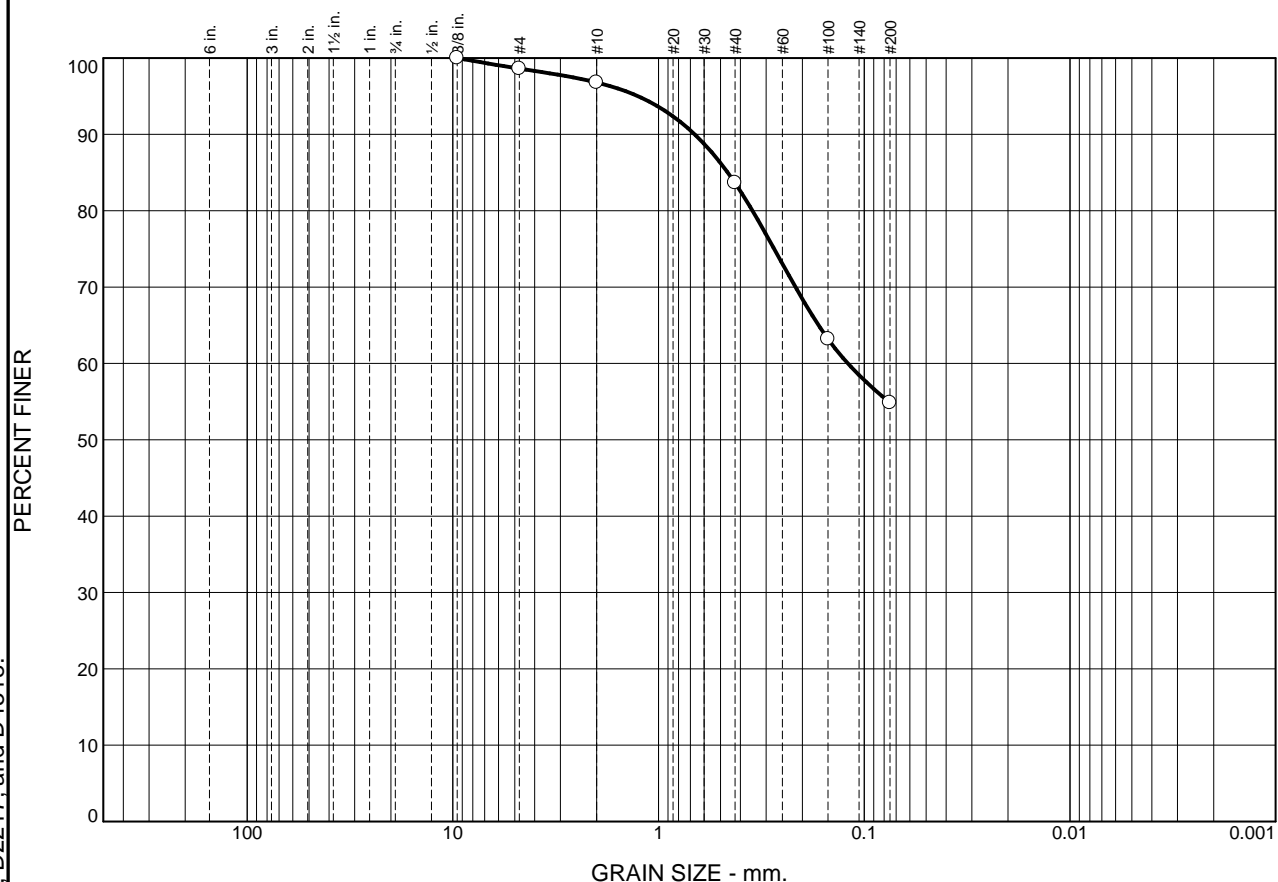
# Particle Size Distribution Report

ASTM Specifications performed my include: D421, D422, D2216, D2217, and D4318.

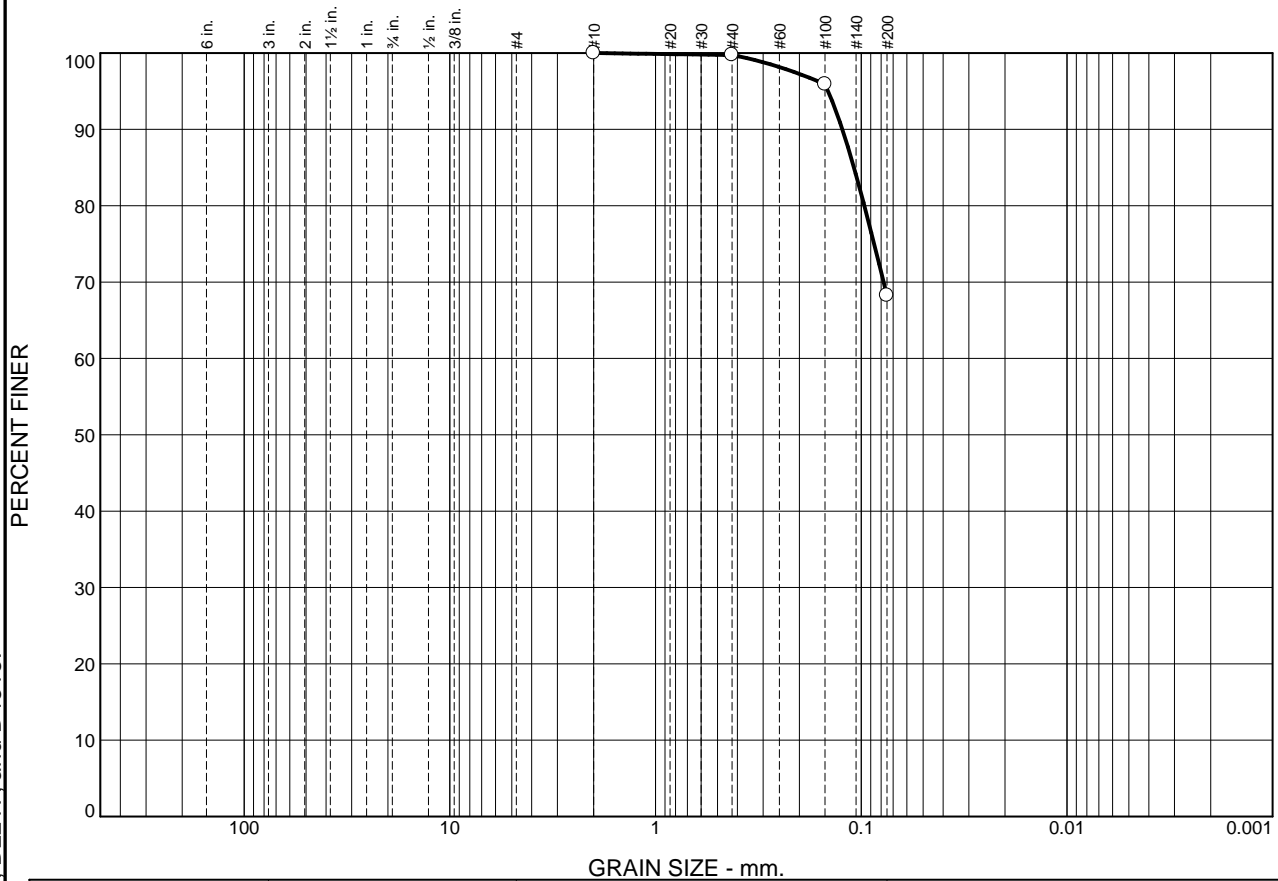
# Particle Size Distribution Report

% +3"	% Gravel		% Sand			% Fines	
	Coarse	Fine	Coarse	Medium	Fine	Silt	Clay
0.0	0.0	0.0	0.0	0.3	31.5	68.2

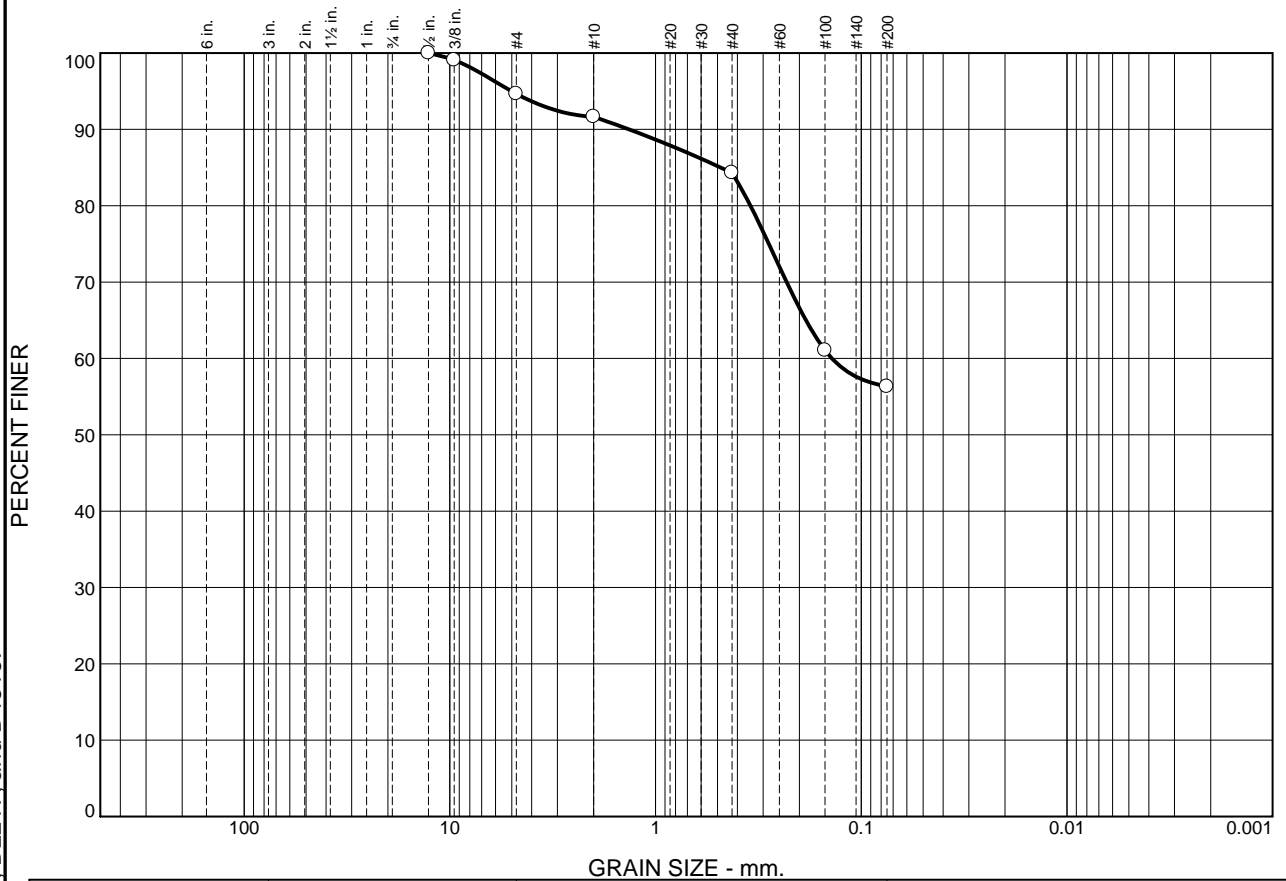
# Particle Size Distribution Report

% +3"	% Gravel		% Sand			% Fines			
	Coarse	Fine	Coarse	Medium	Fine	Silt	Clay		
0.0	0.0	5.3	3.1	7.3	28.0	56.3			
LL	PL	D85	D60	D50	D30	D15	D10	Cc	Cu
NV	NV	0.4826	0.1389

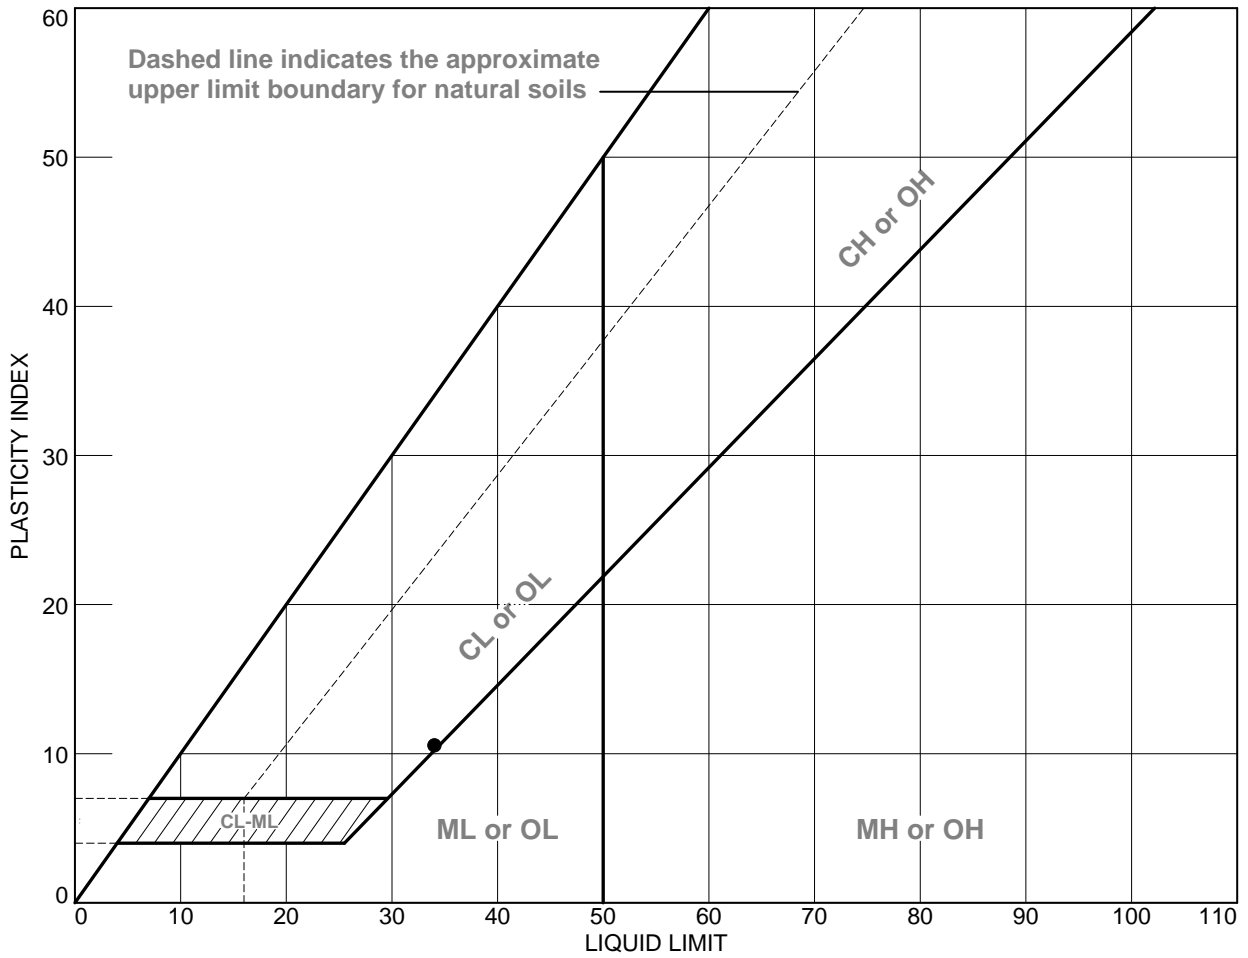
# LIQUID AND PLASTIC LIMITS TEST REPORT - ASTM D4318

SOIL DATA								
SYMBOL	SOURCE	SAMPLE NO.	DEPTH	NATURAL WATER CONTENT (%)	PLASTIC LIMIT (%)	LIQUID LIMIT (%)	PLASTICITY INDEX (%)	USCS
●	TP-1		4.5	21.4	23.6	34.1	10.5	CL

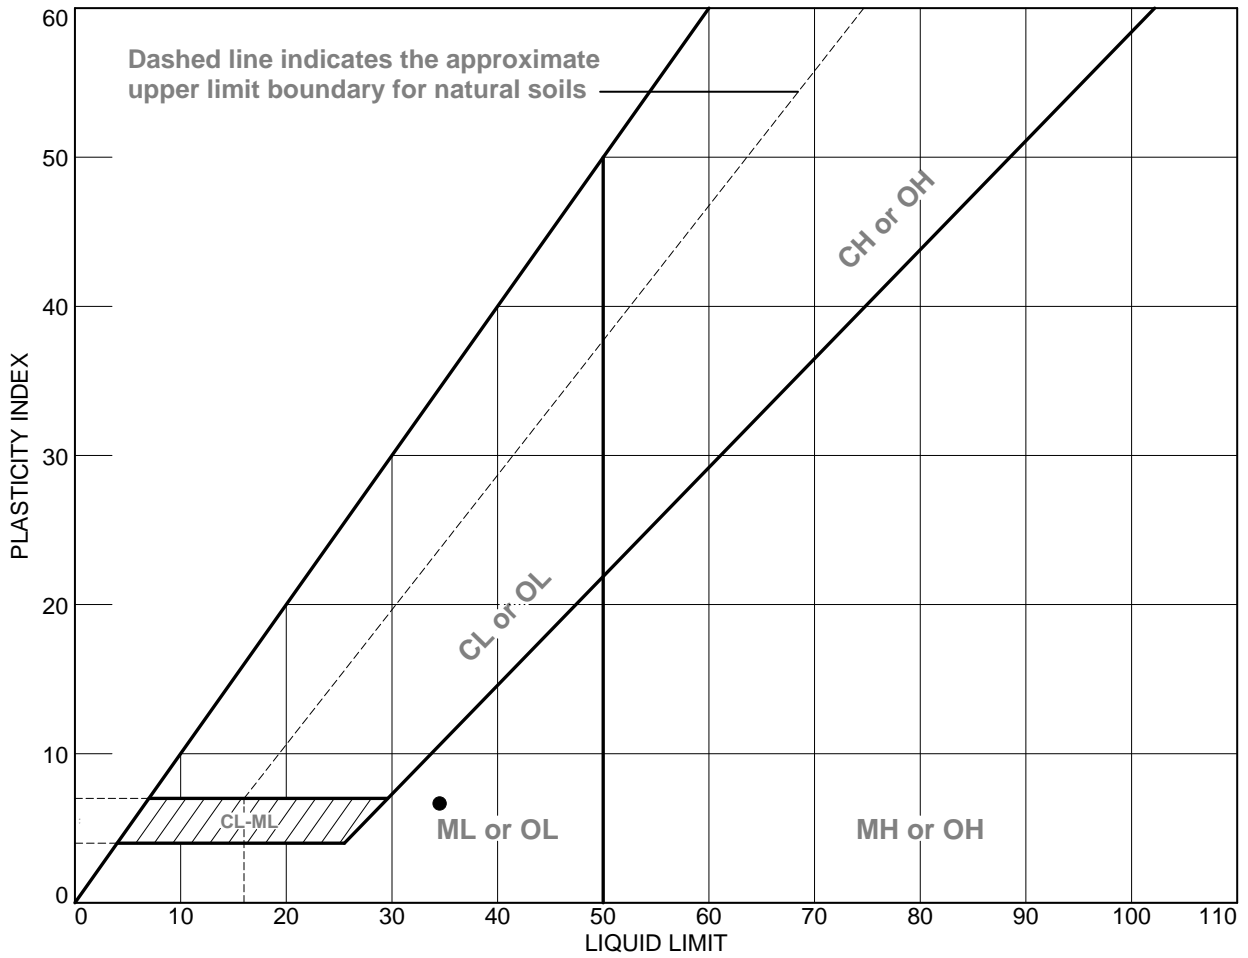
# LIQUID AND PLASTIC LIMITS TEST REPORT - ASTM D4318

SOIL DATA								
SYMBOL	SOURCE	SAMPLE NO.	DEPTH	NATURAL WATER CONTENT (%)	PLASTIC LIMIT (%)	LIQUID LIMIT (%)	PLASTICITY INDEX (%)	USCS
●	TP-9		11	29.3	28.0	34.6	6.6	ML

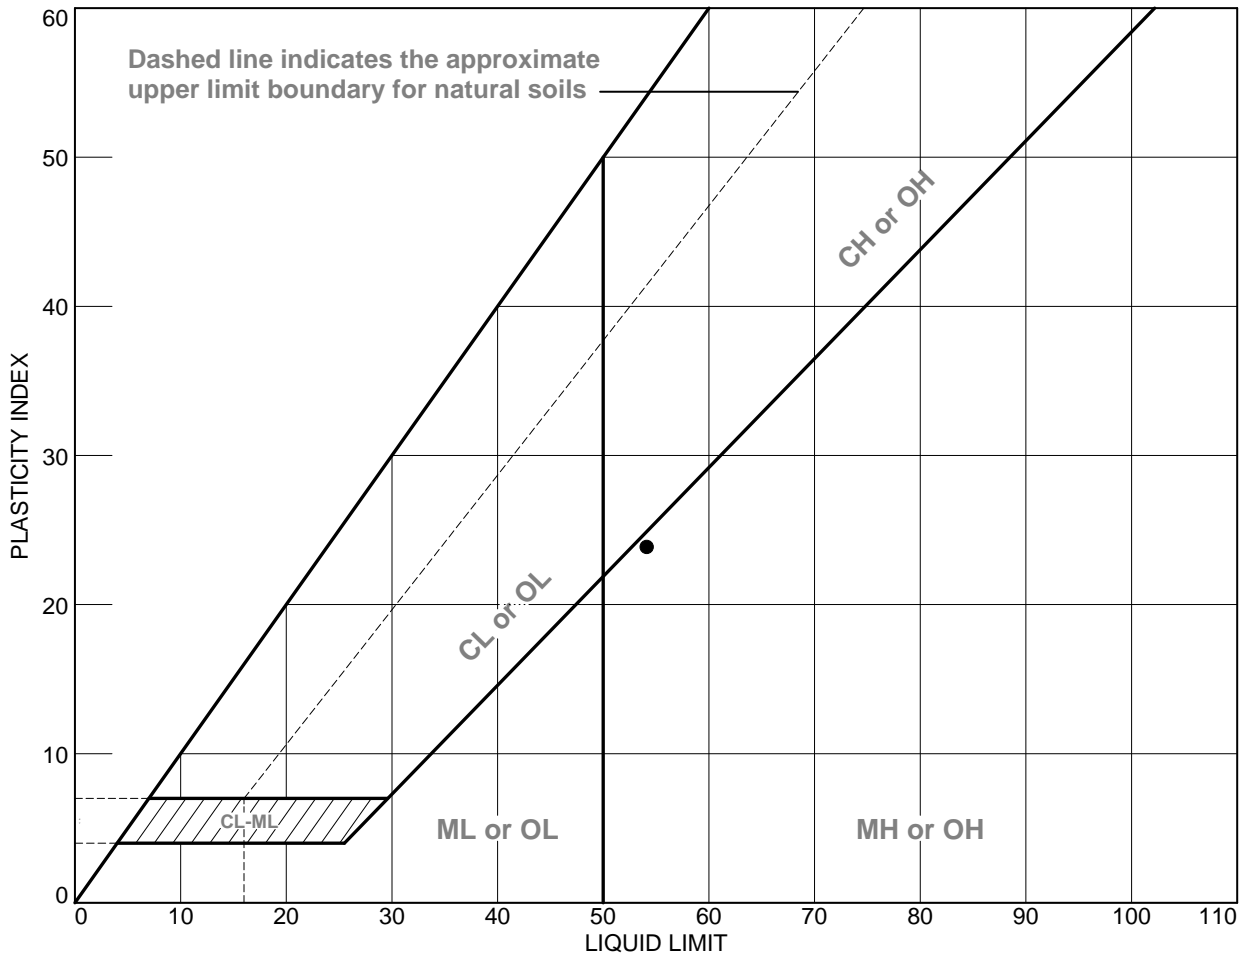
# LIQUID AND PLASTIC LIMITS TEST REPORT - ASTM D4318

SOIL DATA								
SYMBOL	SOURCE	SAMPLE NO.	DEPTH	NATURAL WATER CONTENT (%)	PLASTIC LIMIT (%)	LIQUID LIMIT (%)	PLASTICITY INDEX (%)	USCS
●	TP-13		4.5	28.9	30.4	54.2	23.8	MH
