EAST WINDSOR TOWNSHIP

BICYCLE AND PEDESTRIAN CIRCULATION STUDY

2016

PARSONS
BRINCKERHOFF

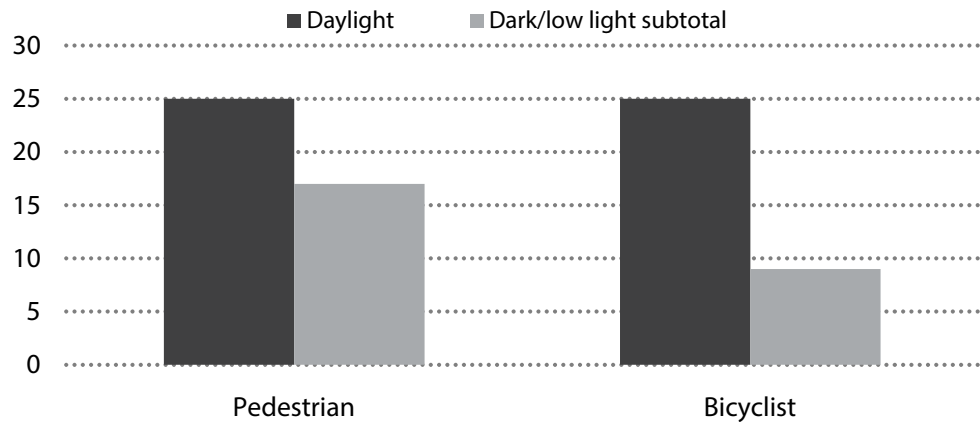
Chart 2.2 - Crash Distribution by Lighting Condition

As shown in Chart 2.2, lighting was not a major factor in pedestrian crashes. Nearly two-thirds (25 crashes, 60%) occurred during daylight conditions. This is comparable to the statewide trend, where 61% of all pedestrian crashes from 2006-2013 occurred during daylight conditions. Similarly, the majority of bicyclist crashes occurred during daylight (25 crashes, 74%), consistent with the statewide trend (75%).

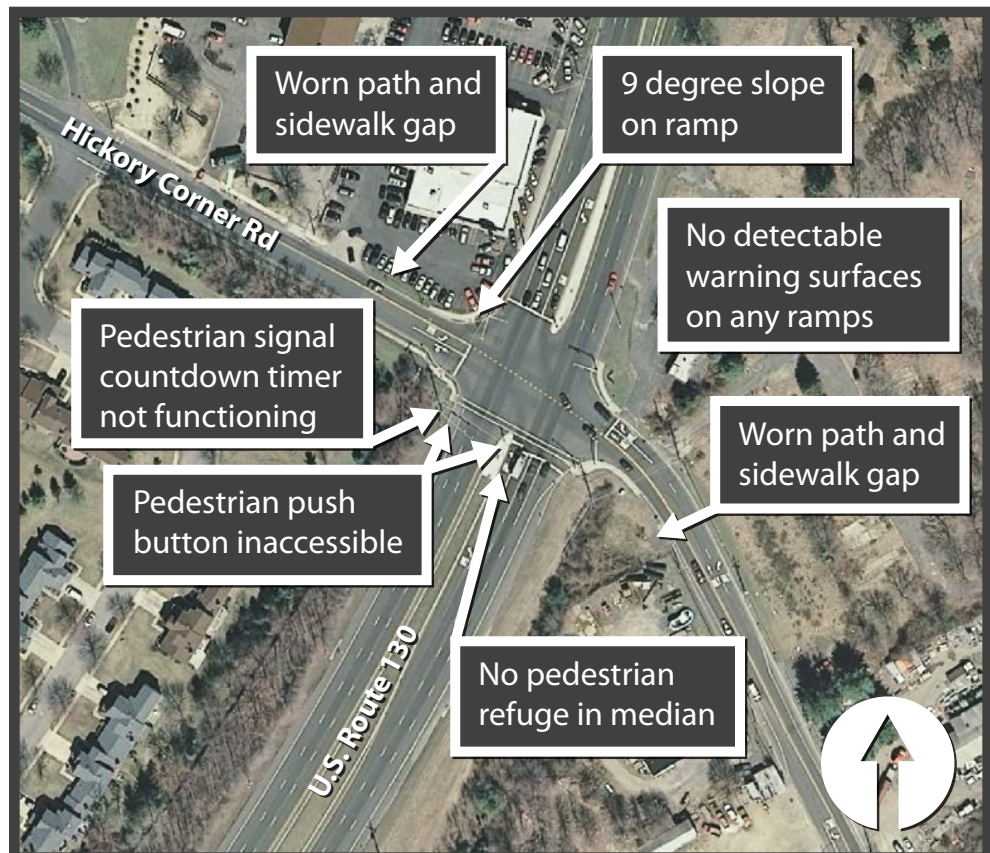
Key pedestrian issues and deficiencies at the intersection include a lack of detectable warning surfaces on curb ramps and limited sidewalk connectivity. These deficiencies make this location a significant barrier for many pedestrians. Existing pedestrian infrastructure is summarized below and deficiencies are highlighted in the annotated aerial photo.

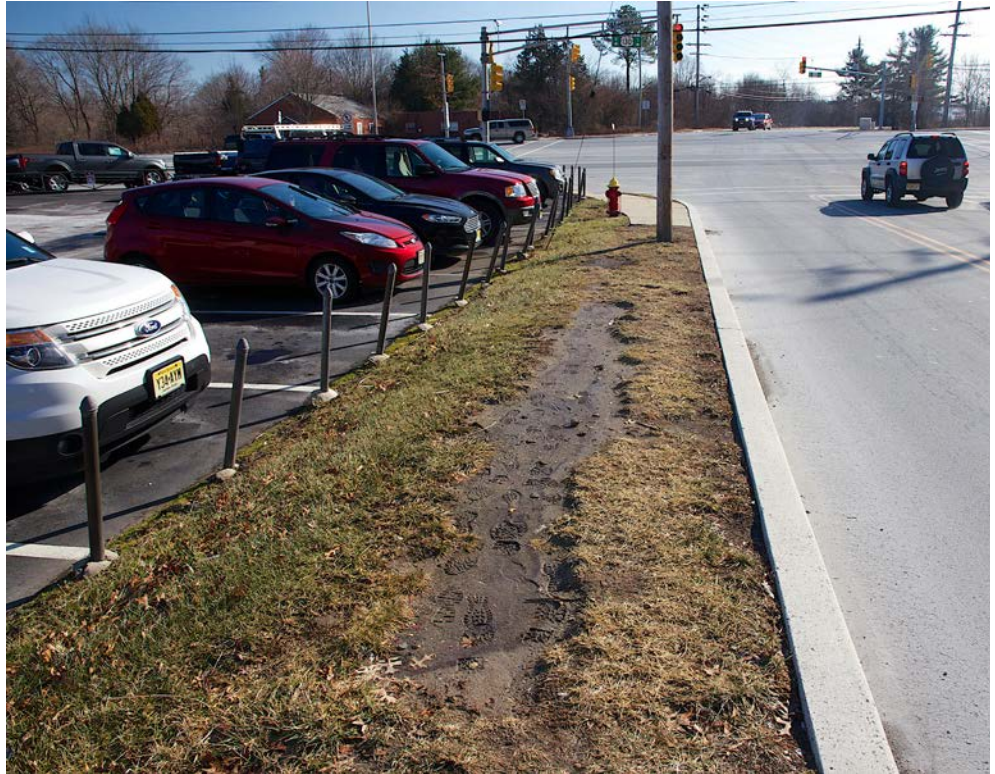
Worn path and utility obstruction along Hickory Corner Road near U.S. Route 130, facing east

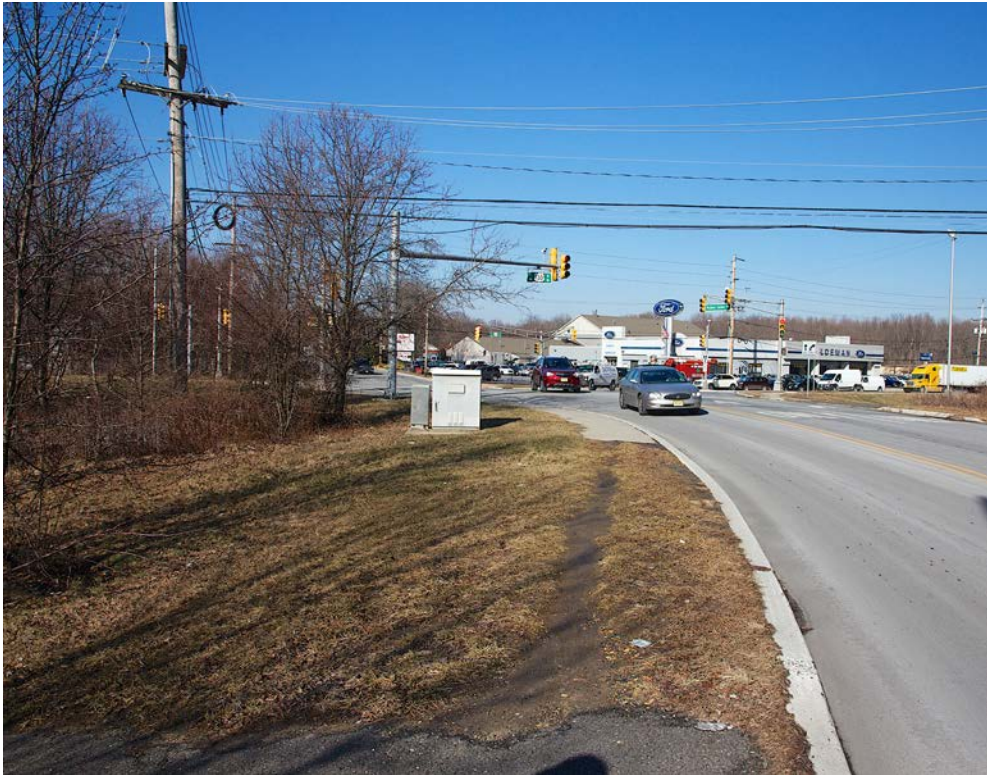
Worn path along Hickory Corner Road near U.S. Route 130, facing west

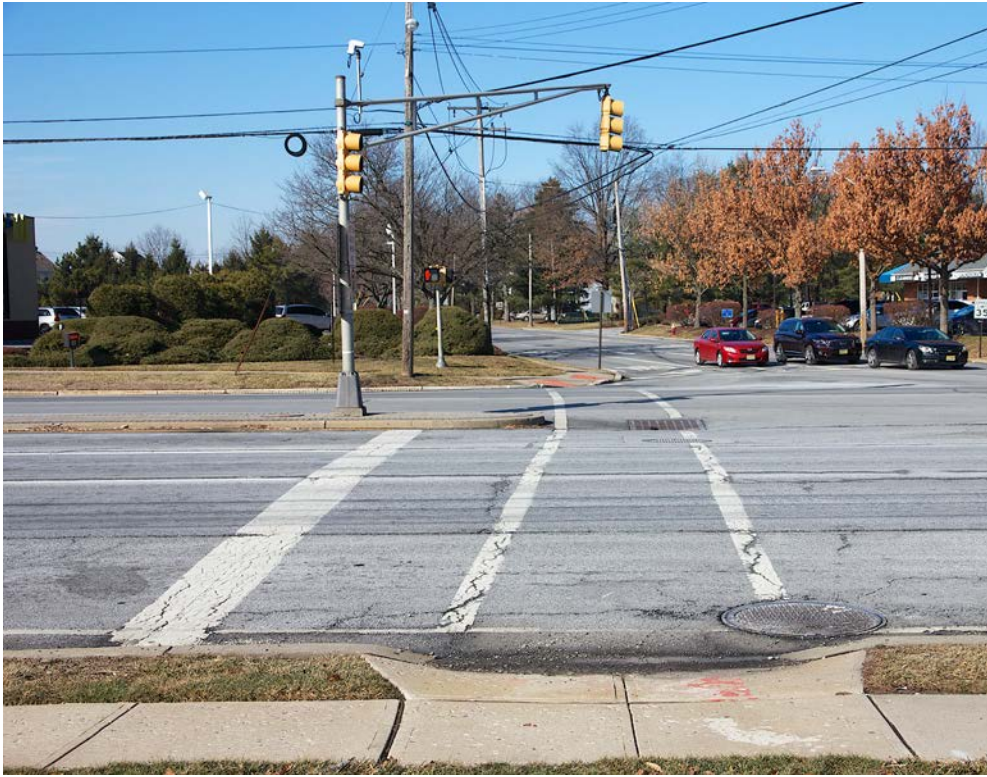
Worn detectable warning surface at SE corner, facing west

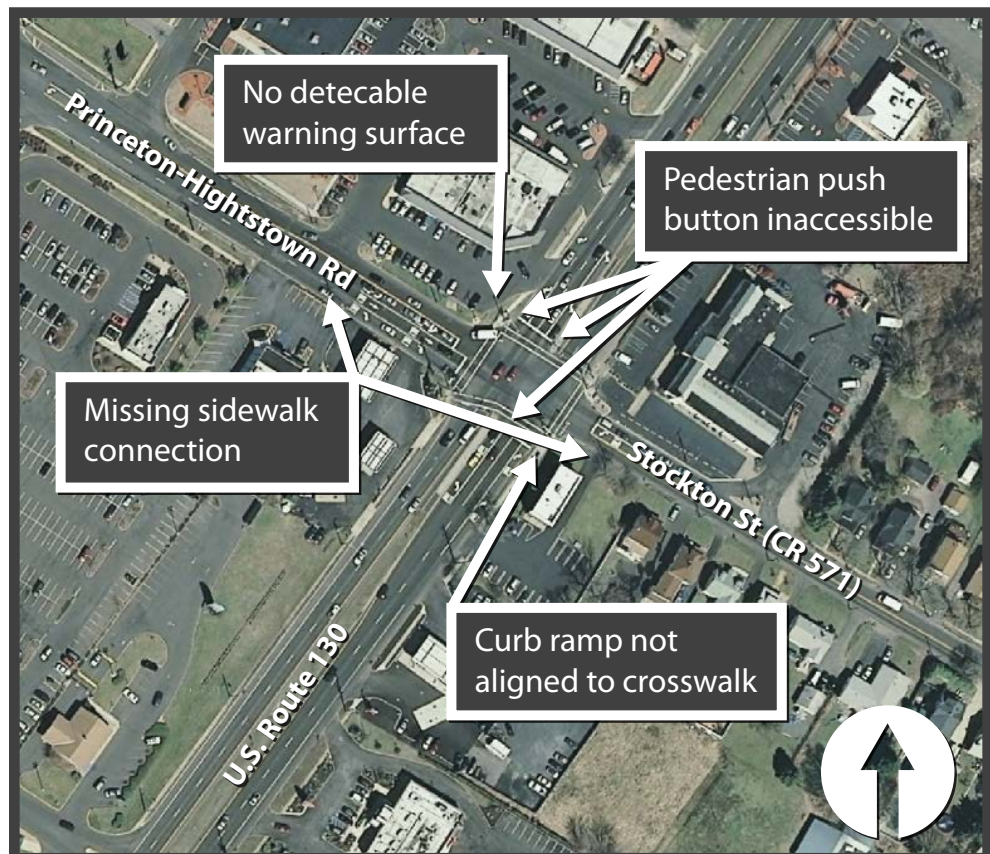
Key pedestrian issues and deficiencies at the intersection include a lack of detectable warning surfaces on curb ramps and missing sidewalks on eastbound approach on CR 571. These deficiencies make U.S. Route 130 a significant pedestrian barrier. Existing pedestrian infrastructure are summarized below and deficiencies is highlighted in the annotated aerial photo.

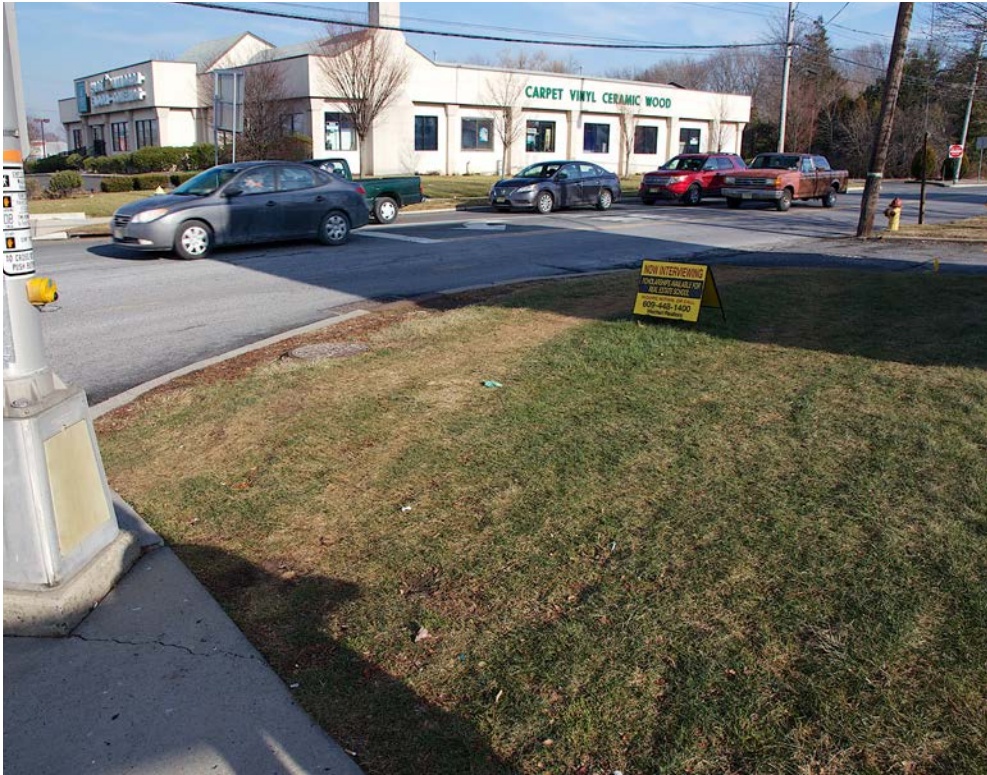
Worn path at SE corner, facing northeast

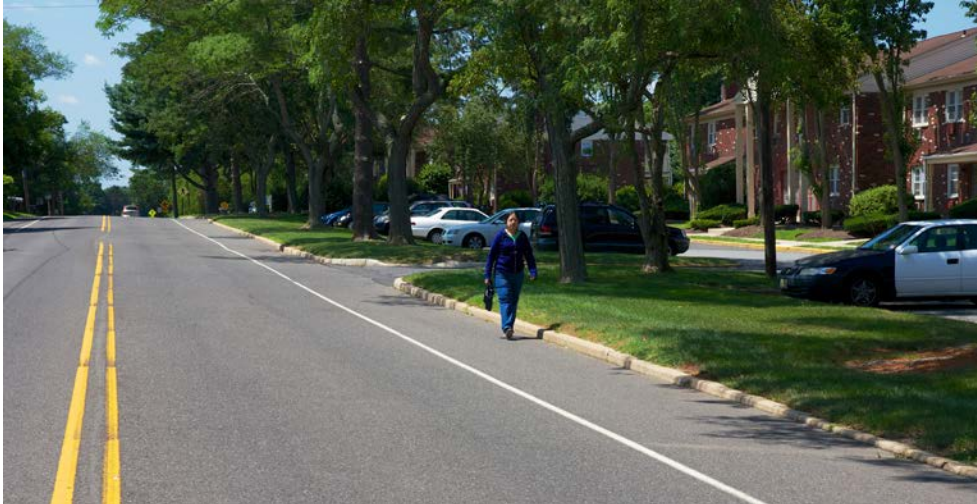
Figure 5.3 | Addition of Sidewalks on Hickory Corner Road

Existing condition on Hickory Corner Road near Oak Creek Road, looking west

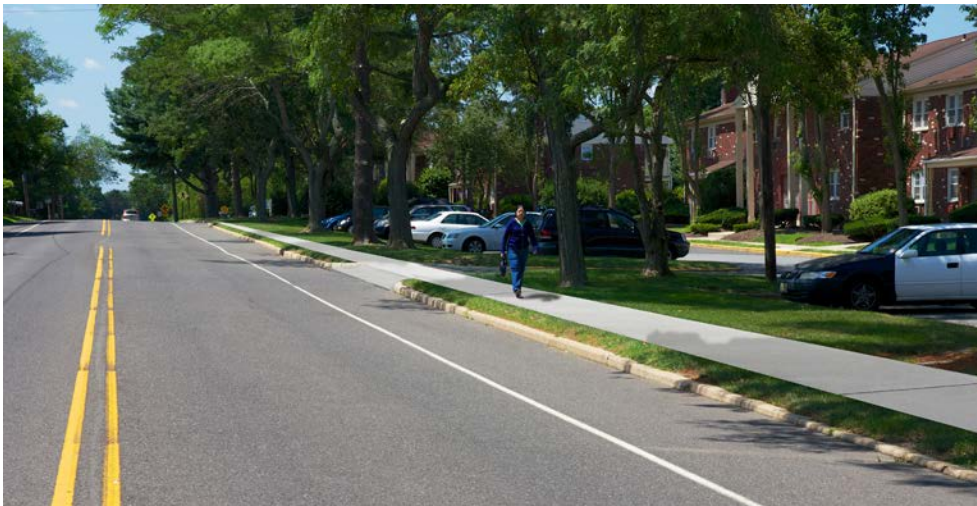
Photosimulation showing the addition a sidewalk in this same segment

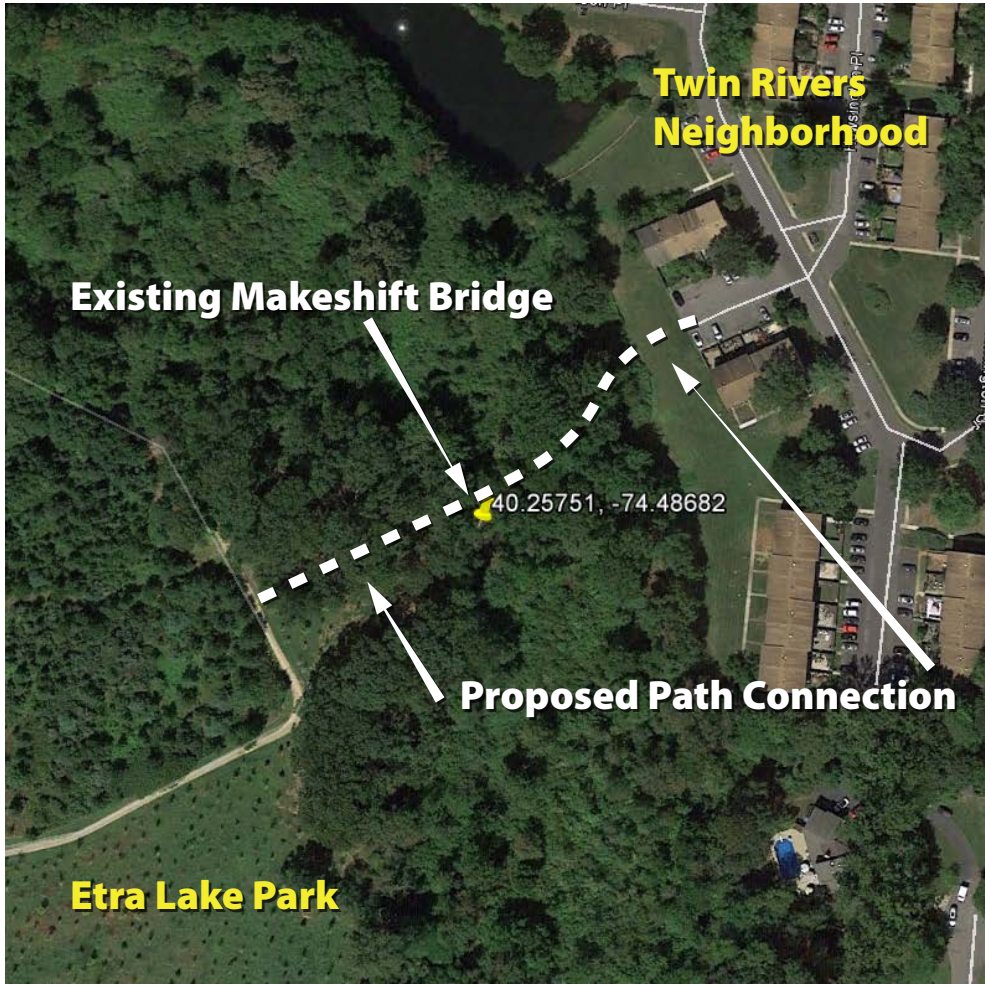
Figure 5.7: Proposed connection between Twin Rivers neighborhood, via Harrison Plan, to Etra Lake Park
